# RESTORING THE LOST SHELLFISH REEFS OF PORT PHILLIP BAY

**Final Evaluation Report | Stage 2 Extension  
November 2017 to December 2018**

Prepared for the Department of Environment, Land, Water and Planning

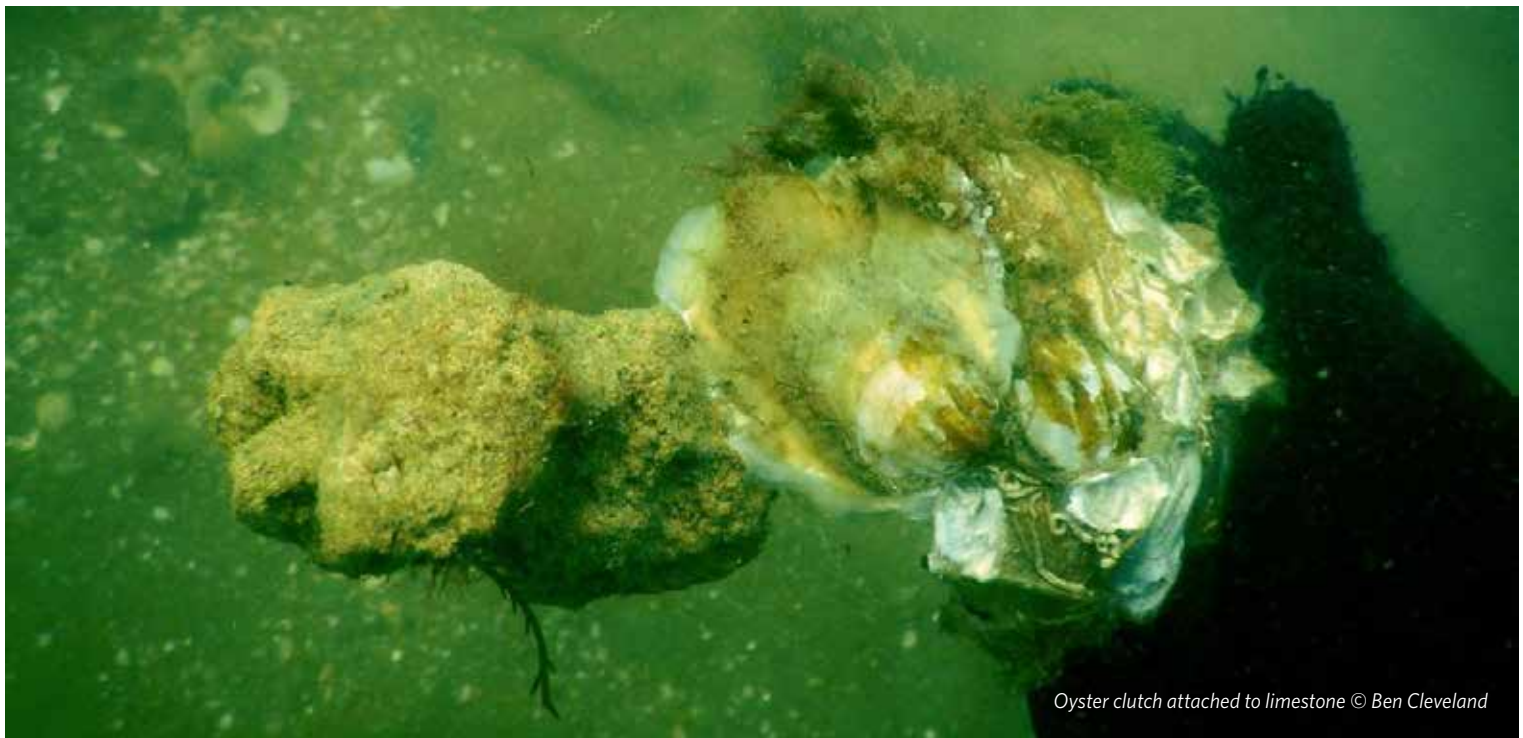
Oyster clutch attached to limestone © Ben Cleveland

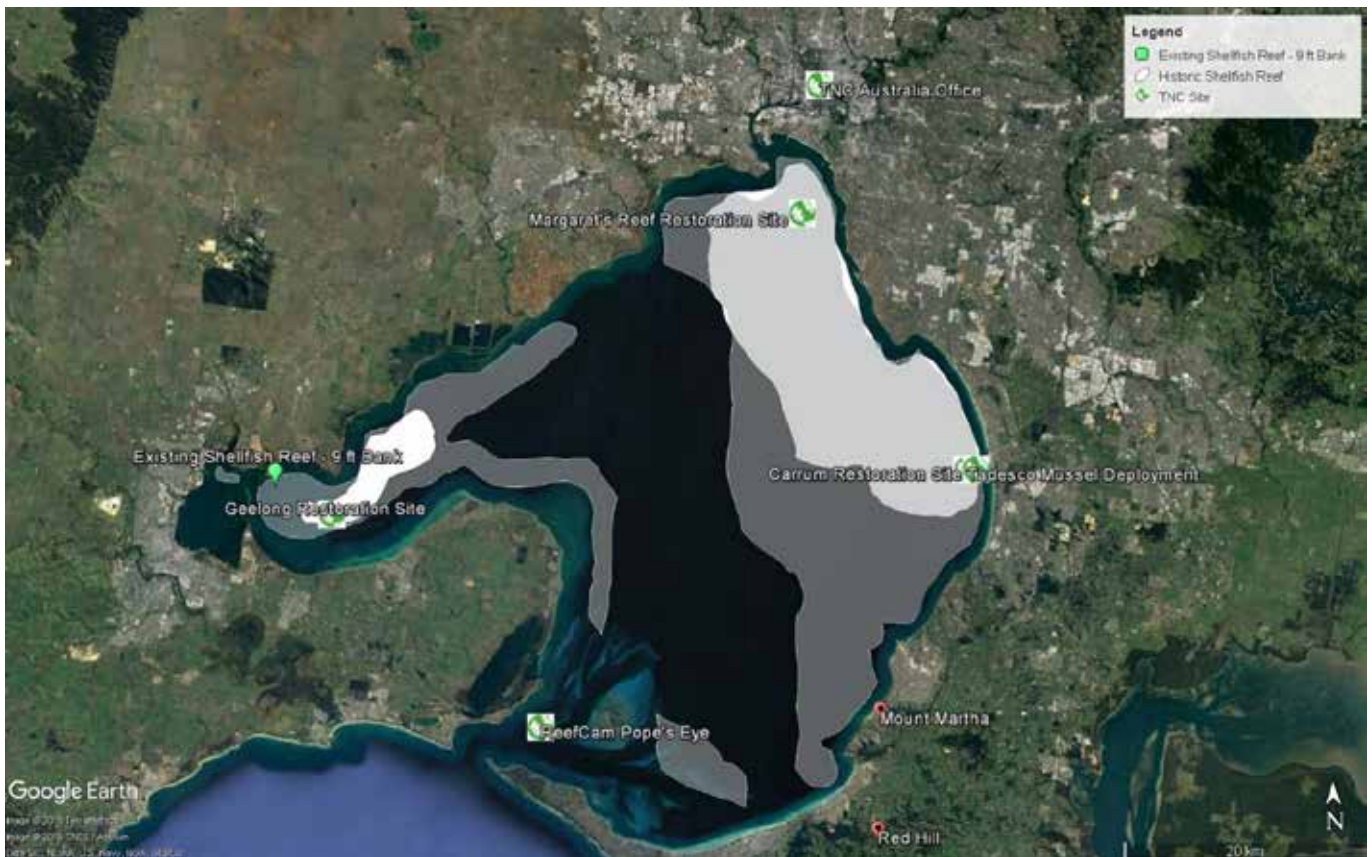
Figure 4: PPB Shellfish Reef restoration permit areas, 9ft Bank and Tedesco Reef

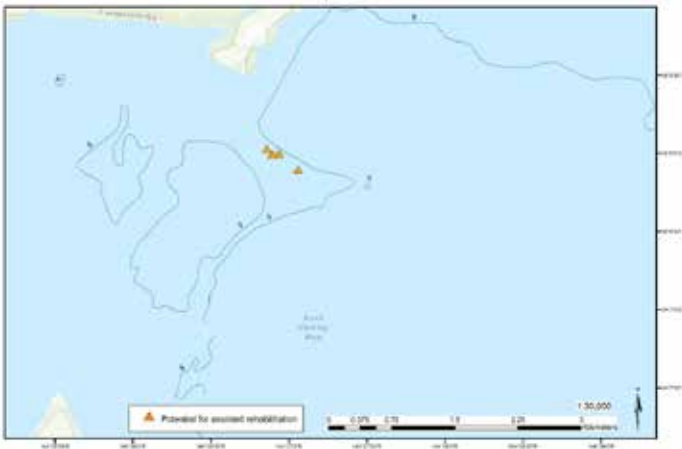
Figure 7: 9Ft Bank exploration area

- 9ft Bank – which was previously known as a potential degraded shellfish reef. The multibeam and towed video survey work has verified the extent of this reef. The next suggested steps, are to first conduct baseline biological monitoring to assess the current ecological community, followed by an assisted rehabilitation trial within a smaller footprint of the area, to test if such an approach is conducive to reef recovery. In addition, the data gathered about 9ft Bank will assist in determining if this site qualifies as a degraded shellfish reef, as part of TNC's nomination of shellfish reefs as a threatened ecosystem under the Environmental Protection and Biodiversity Conservation Act.

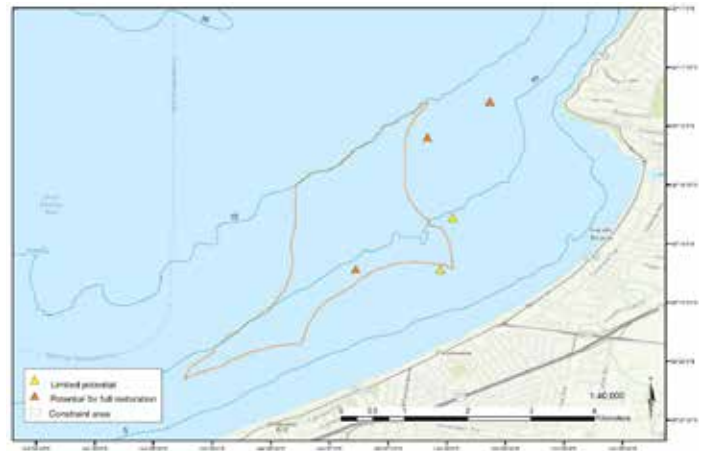
Figure 12: Dromana exploration area
